Architectural Survey and Evaluation

Proposed SR I/Frederica Interchange

South Murderkill Hundred Kent County, Delaware

October 2004

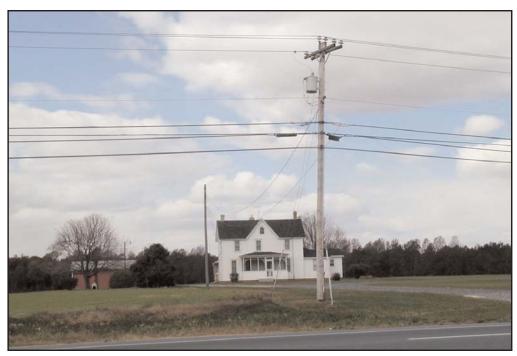
Photograph 1: Overview of SR 1 project area; SR 1 in foreground; Wix/Robbins Property in background. Garage/shed is on the left of the photo. View to west (April 2004).

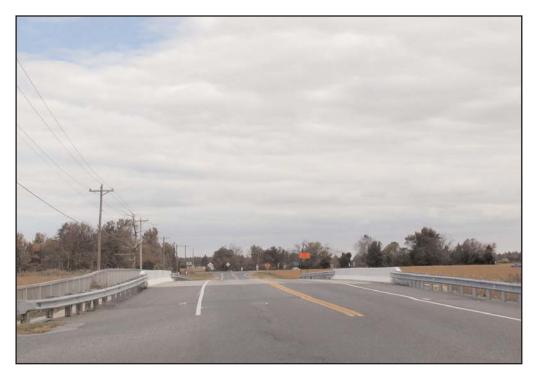
Photograph 2: View of modern bridge over SR 12, looking northeast over Spring Creek (April 2004).

With the exception of Barratt's Chapel, no properties within the study area have been previously evaluated for National Register significance (Figure 2). One historic bridge was surveyed in 1980 (CRS # 5652) and determined not eligible for listing in the National Register (P.A.C. Spero & Company 1991). Since the time of the 1980 survey, the bridge, which dated to 1920, has been replaced with a modern, wider structure.

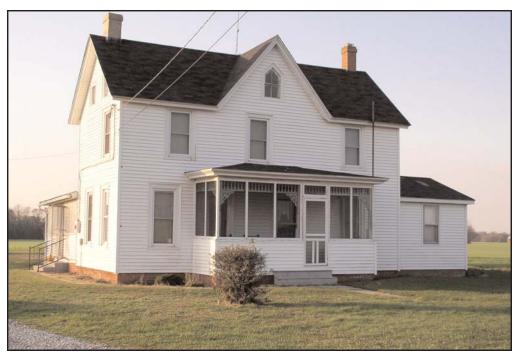
<u>Dwelling</u>. The dwelling is a two-and-one-half-story wood frame vernacular dwelling with a gable ell roof form (Photographs 3, 4 and 6). It rests upon a brick foundation. The entire exterior of the dwelling is clad in vinyl siding. Window openings in the dwelling contain replacement, vinyl, one-over-one, double-hung sash windows and wood four-light casement windows (in the half story). A gable wall dormer is centered in the façade, forming a small cross gable with the main roof. The roof is covered with asphalt shingles. A small brick chimney protrudes from the north interior gable end, and parged chimneys protrude from the south and east interior gable ends. Enclosed porch additions are attached to the façade (east elevation), south elevation, and north elevation. Small, single-story additions are also attached to the north and west elevations.

The façade (east elevation) of the dwelling consists of four bays, including one entrance and three window openings in the first story, and three window openings in the second story. The entrance is located in the second bay from the north end of the wall, and contains a single-leaf door. The window openings contain single windows. The window openings in the second story are not vertically aligned with those in the first story. An additional window opening is centered in the gable wall dormer. A single-story, wood frame, screened-in porch with a hipped roof obscures the first story of the façade. Two concrete steps allow access to the porch entrance, which has a screen door. The dwelling's original open wood porch, with turned posts, scroll-sawn brackets, and spindles, is intact and visible within the screened-in porch.

Photograph 3: Wix/Robbins Property. Façade, view to west (April 2004).

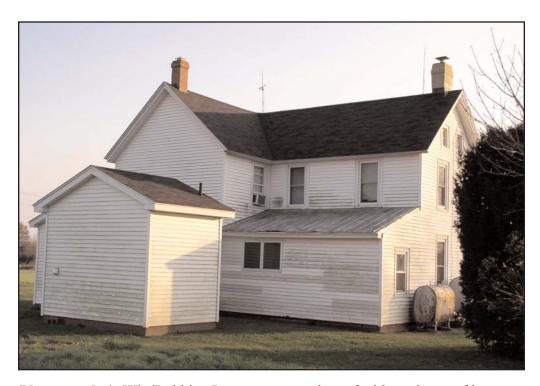
Photograph 4: Wix/Robbins Property - overview of side and rear of house; small wing in foreground is attached to main building. View to the southeast (April 2004).

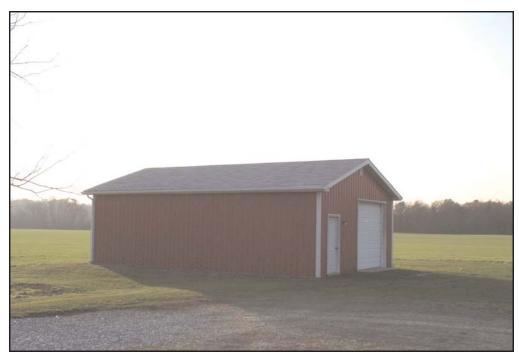
Photograph 5: Garage/shed at Wix/Robbins Property, view to the southwest (April 2004).

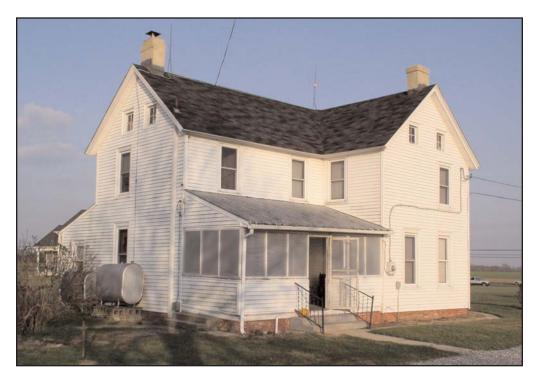
Photograph 6: Wix/Robbins Property showing side and rear of house, view to the northwest (April 2004).

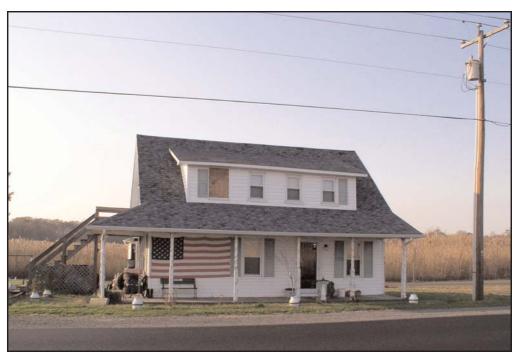
<u>General Description</u>: The Langrell Property is located on SR 12, on the west side of the road (Photograph 7 and 8). The property consists of a dwelling constructed ca. 1925-1930. A small, grassy yard surrounds the building on all sides. The property is in good condition.

<u>Dwelling</u>: The dwelling is a one-and-one-half-story, light frame, vernacular building with a cross gable roof (Photographs 7 and 8). The rear ell that forms the cross gable appears to be a late-twentieth-century addition. The building rests on a concrete foundation. Its exterior walls are clad with vinyl siding. Window openings throughout the dwelling contain single and paired replacement, vinyl, one-over-one, double-hung sash windows. The roof is covered with asphalt

Photograph 7: Langrell Property, overview of façade, view to west (April 2004).

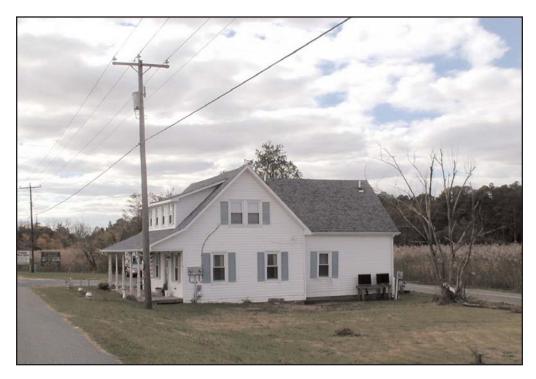
Photograph 8: Langrell Property, overview of north elevation, view to south (April 2004).

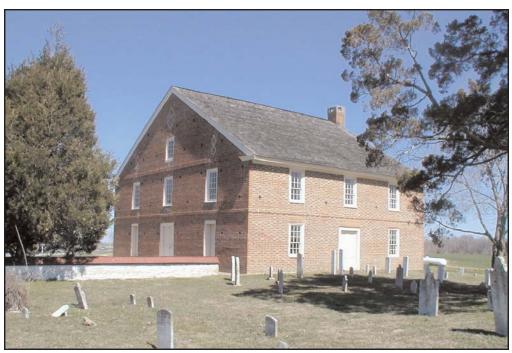
General Description. Barratt's Chapel lies on a large, triangular piece of land abutting the east side of SR 1 (Photograph 9). Although there have been recent land acquisition(s) to the Barratt's Chapel property, the main, historically older, parcel which contains the standing buildings and most of the cemetery is approximately triangular in shape and comprises 24.6 acres. The complex of buildings at this site is at the northwestern corner of the property, near SR 1, and it now includes a small parking lot and several paved driveways. The cemetery however, occupies most of the large expanse of land at this site (Photographs 10 and 11), and the cemetery has been expanding to the east. The cemetery features a variety of headstones, ranging from simple flat (vertical) stone slabs to obelisks and other, larger features and structures, including at least one mausoleum and an (elevated) tomb. There are also a variety of markers, including tall granite shafts. The cemetery grounds feature low-cut grass and several walkways. Trees are sparse, and a brick wall encloses part of the cemetery (Photograph 11). Although the brick wall is not actually a part of the chapel, it abuts the building at two ends. Similar to other Delaware churches of this period, Barratt's Chapel has a central-entry meetinghouse form. These other examples of late-eighteenth-century brick churches in Delaware include Old Drawyer's Presbyterian church (ca. 1773) near Odessa, and St. Anne's church (ca. 1765) near Middletown

Photograph 9: Barratt's Chapel, view to northeast, showing west and south elevations (April 2004).

the POS could probably be expanded to include later time period(s). The chapel, which has been restored, retains very good architectural integrity and it should continue to be considered an eligible resource. The chapel is in good physical condition and retains its essential character-defining elements, such as the three-bay fenestration, broad gable roof, square-form building footprint, Flemish bond brickwork, and molded box cornices. Although the Barrett's Chapel National Register nomination form does not include a boundary description, it would appear that the National Register boundary coincides with the tax parcel.

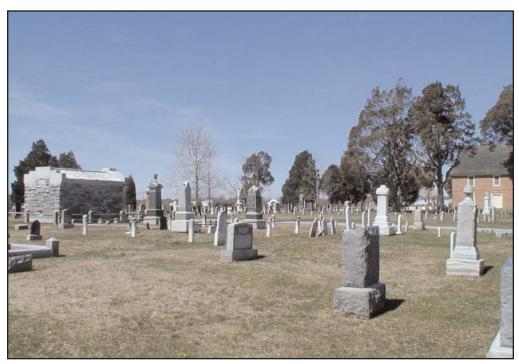
Photograph 10: Overview of cemetery grounds, view to northwest (April 2004).

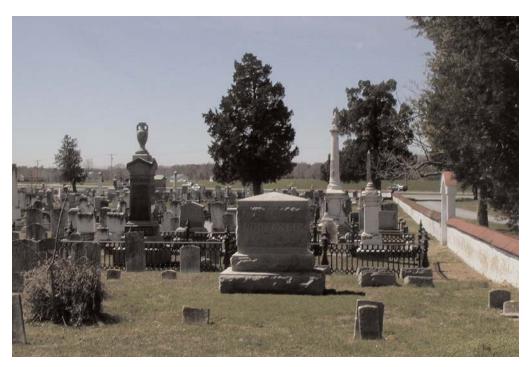
Photograph 11: View of cemetery with cemetery wall and gate to right of photo. View to west (April 2004).

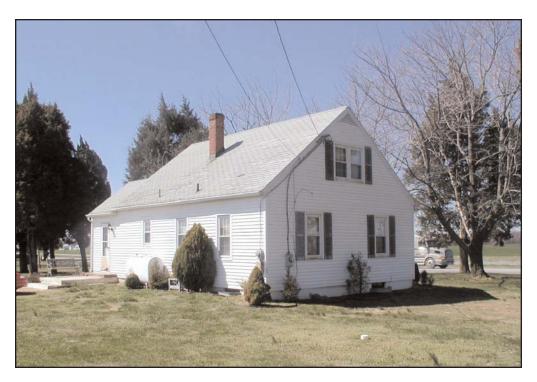
<u>Description of Caretaker's House (CRS # K-103.001)</u>. The caretaker's house (ca. 1941) for Barratt's Chapel is located on the front of the Barratt's Chapel lot immediately along SR 1 (Photographs 12 and 13). The one-and-one-half-story, three-bay Cape Cod/Colonial Revival dwelling is located southeast of the chapel and is surrounded by yard space and mature trees. Overall, the property is in good condition.

The main block of the house has a contemporary one-story addition to the north elevation that is set back from the facade. The walls of the dwelling and addition are clad in vinyl siding and rest on a concrete block foundation. The façade (west elevation) features a central entrance, which is sheltered by a gable front portico and accessed via concrete stairs. Eight-over-eight, double-hung wooden sash windows flank the door. Gable front dormers are located above the window openings in the façade. Six-over-six, double-hung sash wooden windows provide light in through the dormers. Like the windows of the façade and most of the windows in the gable ends, vinyl shutters flank the dormer windows. The roofs of the dwelling and the two gable front dormers are clad in asphalt shingles.

A brick chimney flue protrudes from the rear slope of the roof. A concrete patio with steps provides access to the rear entrance, which is located in the addition. Three six-over-six double-hung windows pierce the rear of the main block and lack the vinyl shutters found at the other elevations. The small size of the second window opening and the location of ventilation stacks in the roof above indicate a bathroom is located in the rear portion of the dwelling. A metal oil tank adjoins the rear elevation of the building.

Photograph 12: Caretaker's house, view to southwest, showing SR 1 in background (April 2004).

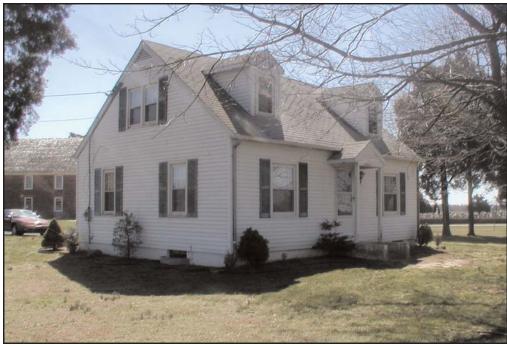
Photograph 13: Caretaker's house, view to southeast with chapel and cemetery in background (April 2004).

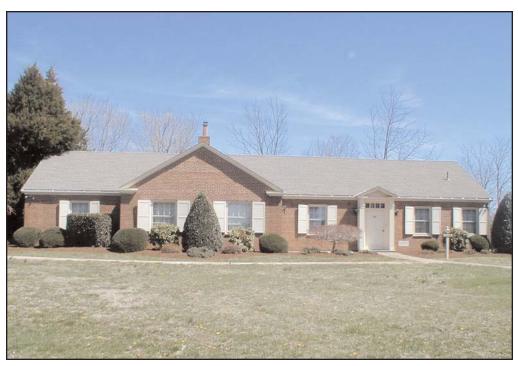
<u>Description of Museum (CRS # K-103.002)</u>. The museum is a one-story brick building resembling a Ranch-style house (ca. 1963-1965; Photograph 14). The primary gable is oriented away from the road (side gable), and there is a shallow ell extending from the northeast corner of the building. The façade is pierced by a cross gable that has two eight-over-eight, double-hung sash windows. The remainder of this elevation features a total of four six-over-six, double-hung sash windows. There is an off-center door on the façade, toward the south end, that features pilaster surrounds capped by a broken pediment. This door also features a transom panel with four lights. There are no windows on the north elevation, and there are two on the south elevation. There are two exterior doors on the rear of the building: the one on the east wall features 12-light glazing and the door on the ell is a solid, single-leaf, paneled door.

Photograph 14: Museum, showing façade (west elevation), looking east/southeast (April 2004).

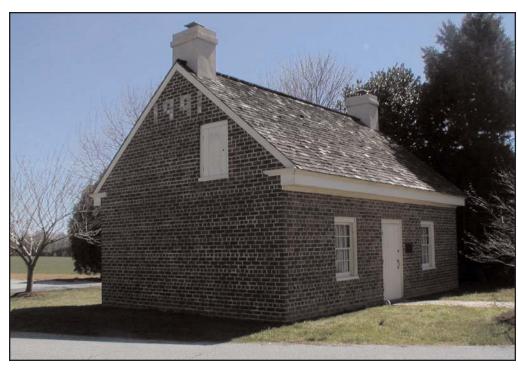
<u>Description of Vestry (CRS No. K-103.003)</u>. The vestry is a one-story brick building that was constructed in 1991 to resemble an eighteenth-century-style vestry (Photograph 15). The vestry is sited just north of the Barratt's Chapel Museum, and there is a paved walkway on the west side of the building that leads to one of the entrances. This rather diminutive building has stuccoed, interior brick chimneys at each gable end, and the building is generally oriented with its gable roof running north-south. There are wood box cornices with returns, and the building's roof is protected with wood shingles.

On the north end gable wall, just beneath the chimney, light-colored glazed bricks bear the lettering "1991" to indicate the year when the building was constructed. Just below and to the west of the "1991" is a small wooden door that is very similar to the vertical beaded-style door on the west and east elevations. The door apparently allows access to the roof crawl space from the outside. The south gable wall was masked by trees and was not visible for inspection.

Photograph 15: Vestry, showing north and west elevations; view to southeast (April 2004).

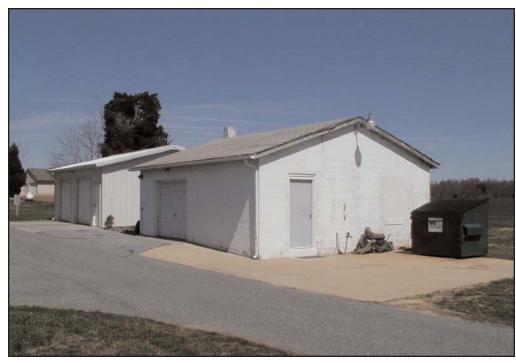
<u>Description of Modern Garages/Sheds – (CRS # K-103.004 and K-103.005)</u>. There are two modern garages/sheds on the Barratt's Chapel property (Photograph 16). They both stand side-by-side, each with gently pitched gable roofs. The garages/sheds rest on, and are surrounded by, concrete pads. No. K-103.005 is an aluminum shed with two overhead garage doors and a small pedestrian door on the west elevation. No. K-103.006 is constructed with concrete blocks, and it has an overhead garage door on the west wall and a pedestrian door on the south wall. Adjacent to the pedestrian door is the ghost of a filled-in window, and there are also ghosts of filled-in windows on the east wall. There is a small, stuccoed chimney on the north gable end of this building.

Photograph 16: Sheds located to southeast of Barrett's Chapel, view to north (April 2004).
